Garware Polyester Limited

Explosion Range Testing
ComBlast 2005 Part 1
March 17th 2005

Test Report Ref: GDA/71-1701s

Date: 18/05/2005

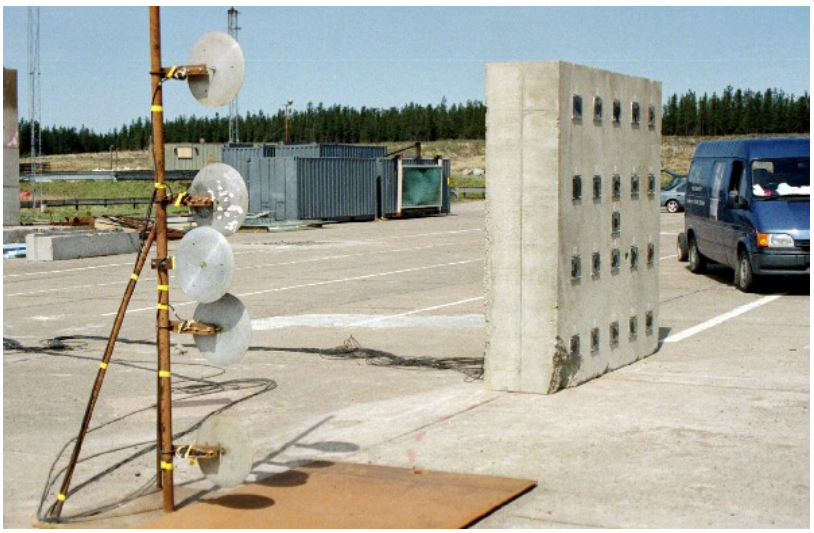
Photos show free field gauges [P1] for measuring side-on incident pressure and the gauge block [P2] used for measuring reflected pressure on face of test specimen.

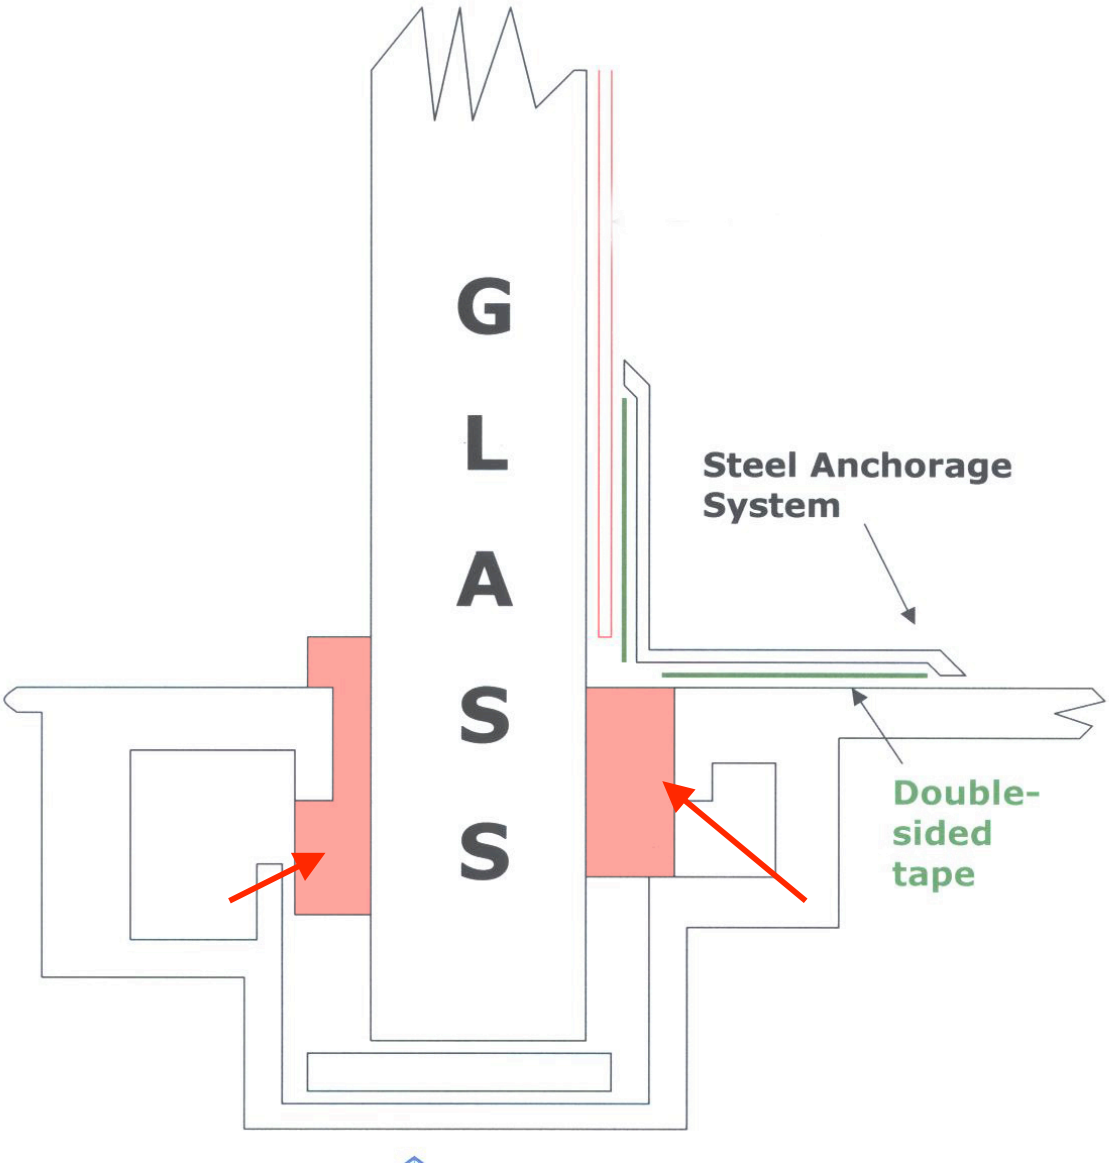
Annex C: Drawings Of Test Specimen

The above sketch is illustrative only of the arrangement of the window film and the Bomb Gard anchoring system. The glass was retained by compression type wedge gaskets at the locations indicated by the red arrows and not by an adhesive tape as implied by the shape of the gasket in the above sketch. The compression gaskets were approximately 8mm in height.
