STANDARD HOME INSPECTION

5678 North Sample Circle
Mesa, AZ

INSPECTION DATE
October 26, 2026

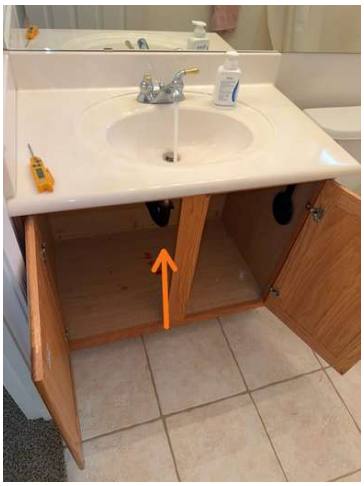
3.3.1 · Interior Areas - WMC

Bathroom - Indications of Past Water

There were indications of past leaking and/or standing water present on wall(s), baseboard(s), flooring, and/or other building materials in the referenced bathroom(s). This condition may be associated with prior plumbing leaks, fixture failures, or moisture intrusion at wet-area assemblies.

It is recommended to inquire with the seller(s) regarding any known history of leaks or water intrusion in this area. Further evaluation of the affected materials, with repairs or replacement made as needed to address any damage, is recommended to be performed by a qualified contractor.

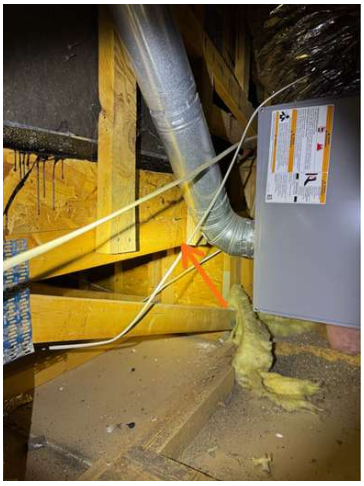
3.4.1 · Roof Structure - WMC

Roof Structure - Indications of Past/Present Leaking Present

There were indications of water leakage present at roof framing and/or roof sheathing components within the attic. Roof leaks can be intermittent in nature and may only occur under certain weather conditions, such as heavy rainfall or wind-driven rain. Based on conditions at the time of inspection, it could not be determined whether the staining was associated with a past event or an active leak.

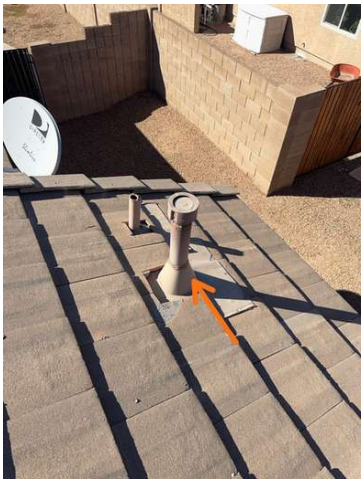
6.4.4 · Roof Flashings/Protrusions

Flue Pipe(s) - Missing Storm Collar

There were flue pipe(s) present with missing storm collars. Storm collars help to prevent water infiltration in between the flue and flashing. Repairs to install proper storm collar(s) is recommended to be performed by a qualified contractor.

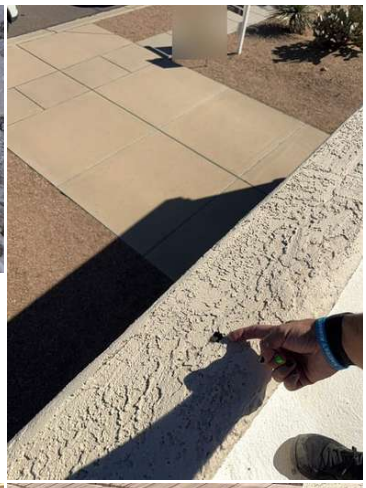
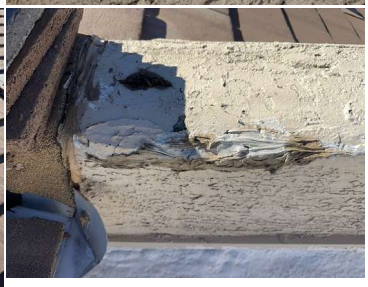
6.11.1 · Parapet Walls

Parapet Wall Damage and Gaps Observed

EXTERIOR - PARAPET WALLS

Observed damage and gaps, along with evidence of prior repairs, at several locations on the **parapet walls**. Further evaluation and repair are recommended to address potential water intrusion.

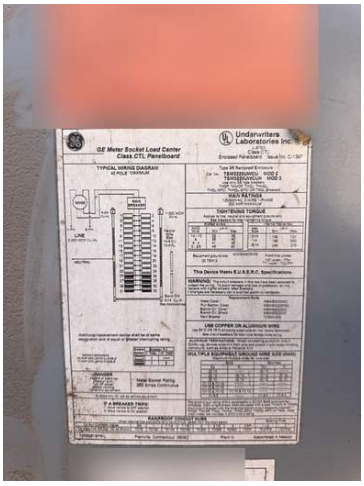
Electrical Panel / Service Equipment Location

- **Right Side of Structure**

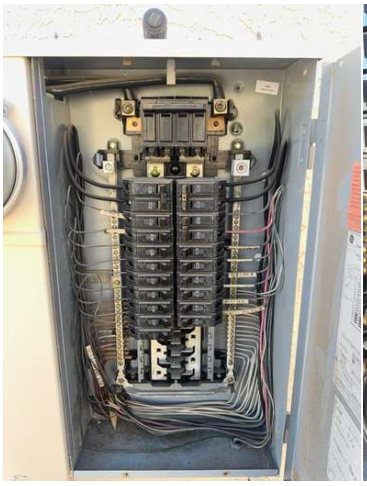
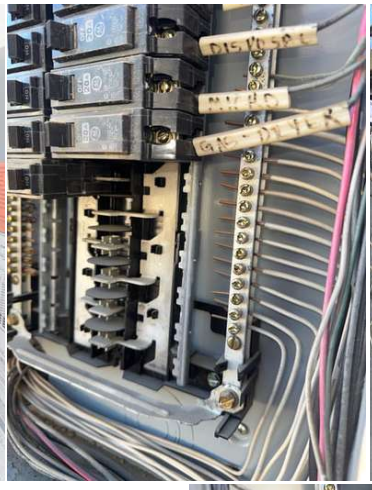
Visible Branch Wiring Type

- **NM Sheathed Cable**

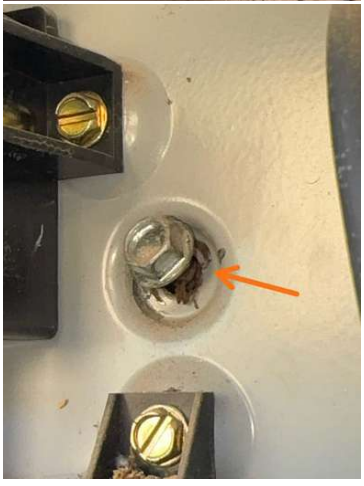
The main electrical panel is secured to exterior wall plywood that shows water damage and previous sealant repairs. Panel appears to be partially pulled away from the wall and some of the fasteners are loose. Recommend consulting the homeowner for more information and further evaluation by a licensed electrician for proper mounting.

A roof scupper is present above the electrical panel and I recommend extending the scupper or adding a gutter to divert water away from the electrical panel.

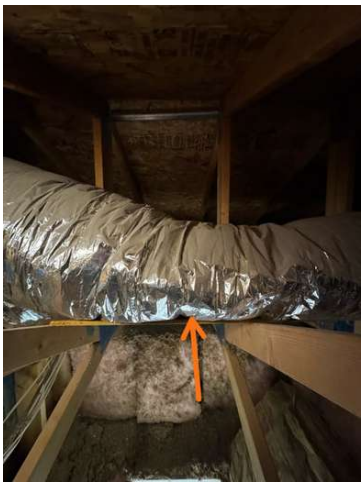
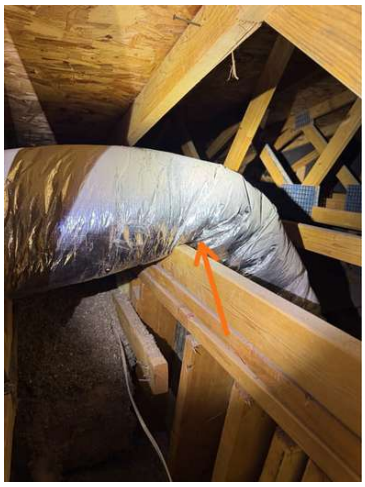
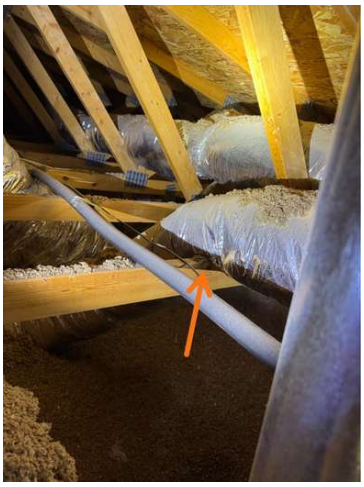
12.12.2 · Visible Ductwork

Ductwork - Sagging/kinked

There were sections of the ductwork that were not properly secured, which resulted in noticeable sagging or that were kinked at the referenced area(s). Sagging ductwork can restrict airflow, reduce system efficiency, and allow condensation to collect in low points of the duct. Current standards recommend supporting flexible ductwork with straps at least 1.5 inches wide, installed at intervals of no more than 4 feet, with a maximum sag of 1/2 inch per foot between supports. An evaluation of the ductwork with repairs made as needed to properly support and restore the ducts is recommended to be performed by a licensed HVAC contractor.

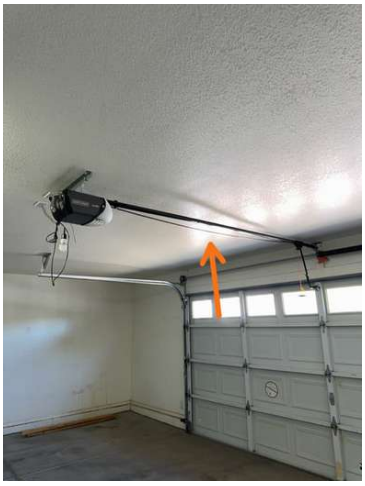
Door seals - Aged

AGED - The garage door seals are aged. Recommend replacement of the bottom door seal.

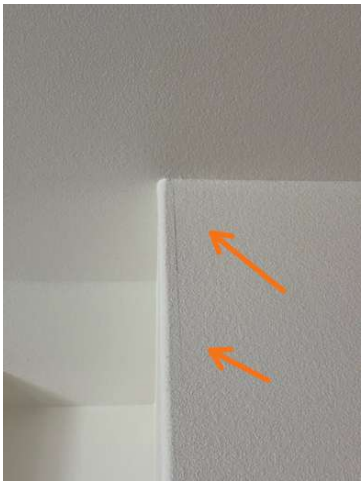
Primary Bedroom

16.7.2 · Wall & Ceiling Surfaces

Drywall - Minor Cracking/Separation in Areas
