Breathe Easy Home Inspections
(480) 254-5708 breatheeasyinspectionsaz@gmail.com

STANDARD HOME INSPECTION

9012 South Sample Ave
Mesa, AZ

INSPECTION DATE
November 7, 2026

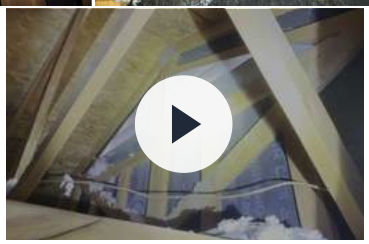
3.4.2 · Roof Structure - WMC

Gable Wall(s) - Moisture Staining

There was moisture staining present on the referenced gable wall. I can only report on the conditions as they existed at the time of inspection and can not confirm the source of the staining. However typically this is from wind driven rain through the vent. No moisture observed during the inspection.

RECOMMENDATIONS INQUIRE W/SELLER(S) MONITOR

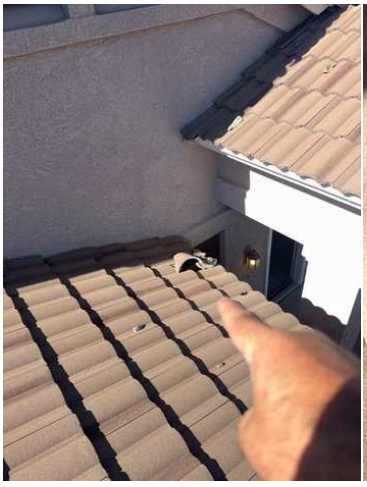
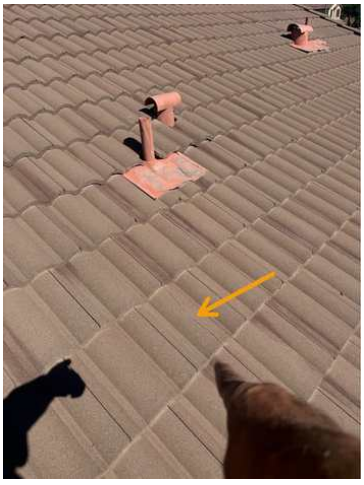
Cracked or Broken Tiles

Cracked and/or broken concrete tiles were observed in the referenced area(s). This can allow moisture to penetrate beneath the tiles, potentially leading to underlayment deterioration, roof leaks, and structural damage. Repairs or replacement of the damaged tiles as needed are recommended to be conducted by a qualified roofing contractor.

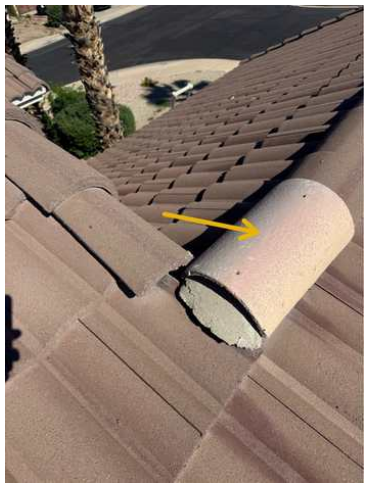
Various Locations

During inspection, several ridge tiles were observed to be loose and not properly secured on the concrete tile roof. This condition may allow water infiltration and pose a slip hazard. Recommend securing or replacing the affected tiles.

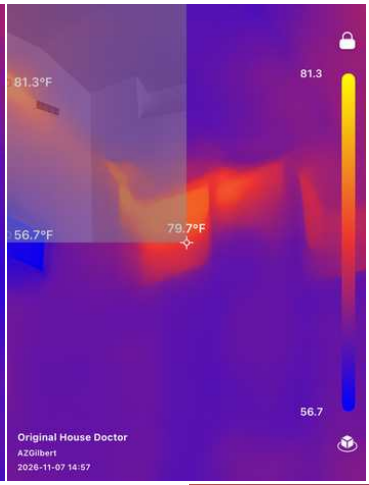
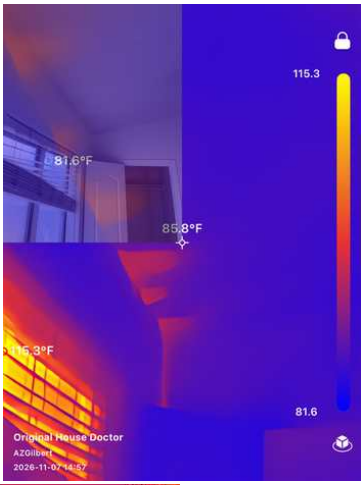
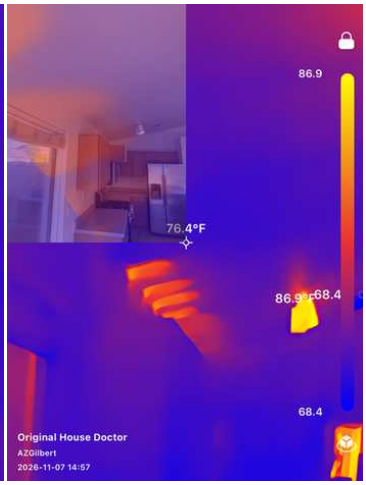
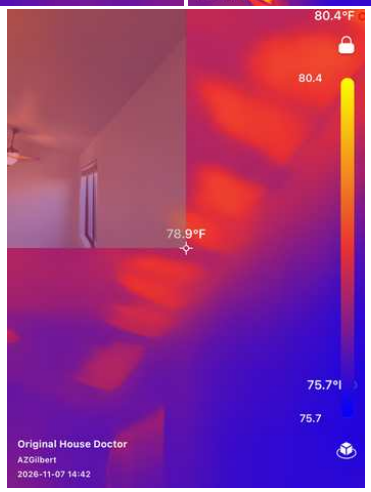
Various locations

Thermal imaging revealed sparse or missing **insulation** in walls and ceilings at several areas. This reduces **energy efficiency** and may affect comfort. Recommend installing appropriate insulation to meet current standards.

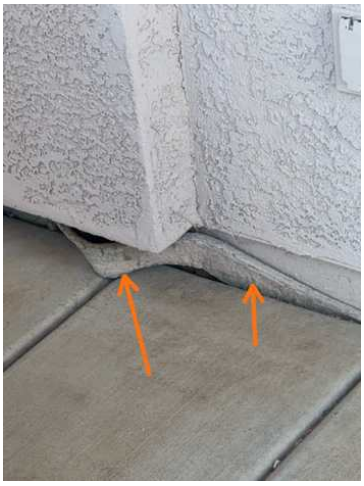
7.2.2 · Foundation Material & Condition

Expansion Joints Bubbled

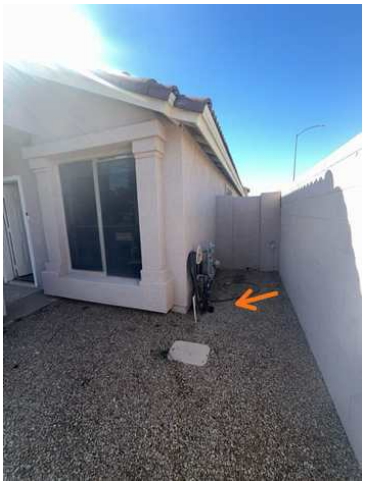
EAST

Grading - Inadequate/Improper Slope

There were grading conditions at the referenced area(s) that were not properly sloped away from the structure. Improper grading can reduce the effectiveness of rainwater drainage and increase the likelihood of soil saturation, moisture intrusion, and foundation-related concerns.

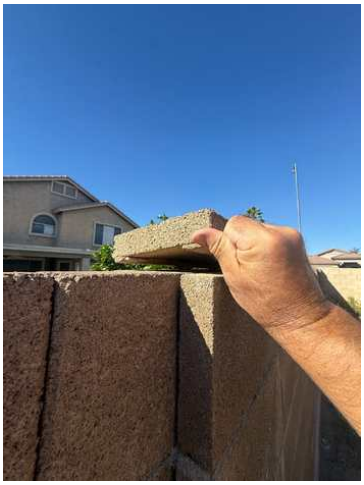
9.7.2 · Privacy Walls

Privacy Wall - Loose Cap on Cinder Block Pillar

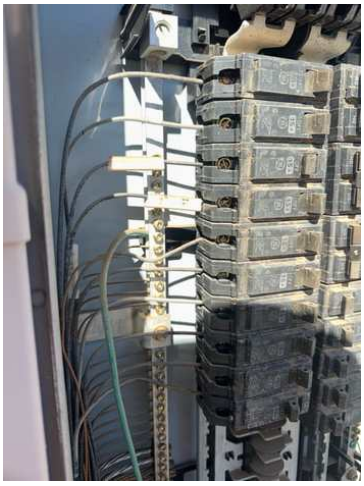
LMT – The service panel cover may not have been removed due to one or more conditions noted above, if applicable. Removal of the cover was not performed where it was not considered safe or readily accessible. When access to the interior of the panel is restricted, the inspection is limited to exterior observations only. Internal components, including wiring terminations, grounding and bonding, bus bars, and overcurrent devices, were not visible and could not be evaluated. Defects may be present within the panel that were not observed.

Once the panel is made safely accessible, further evaluation of the interior components is recommended to be performed by a licensed electrician.

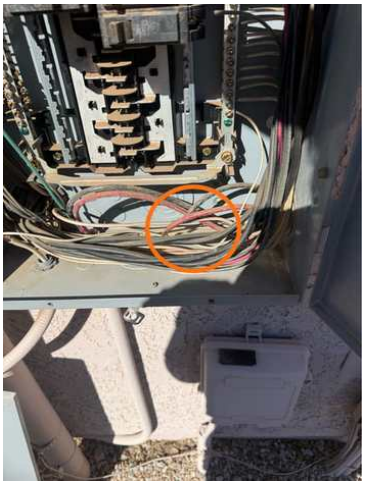
Cover - Incomplete, Incorrect, or Missing Legend

The breaker legend for the electrical panel was missing, faded, incomplete, or illegible at the time of inspection, so individual circuits could not be clearly identified. A properly labeled panel allows circuits to be accurately identified and safely shut off when needed for servicing, emergencies, or future work. Identifying and labeling the breakers is recommended to be performed by a licensed electrician.

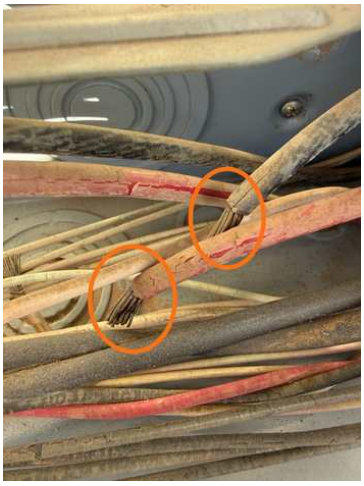
10.7.4 · Wiring Type

Electrical Panel - Disconnected Wiring Without Wire Nuts

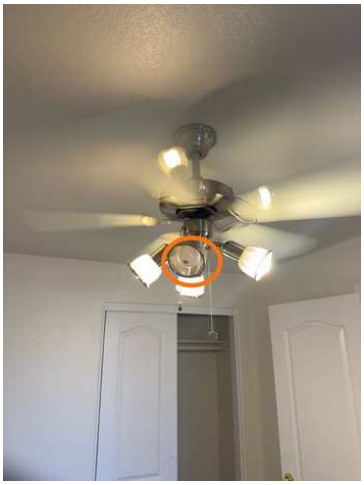
Front, Bedroom

Fan Light - Not Functional

The referenced ceiling fan light(s) were not functional at the time of inspection. This may be as simple as a burned-out bulb, but the possibility exists that it could be more extensive. I recommend confirming proper operation of the light(s)prior to closing.

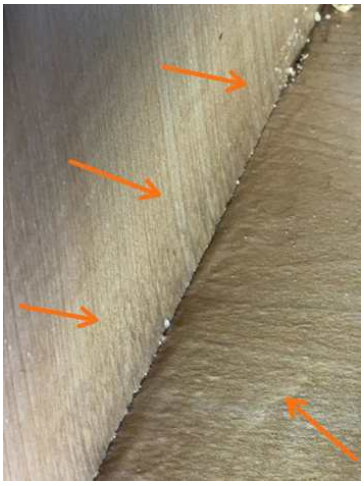
12.2.1 · Plumbing Leaks Information

Undersink Moisture Damage - Minor to Moderate

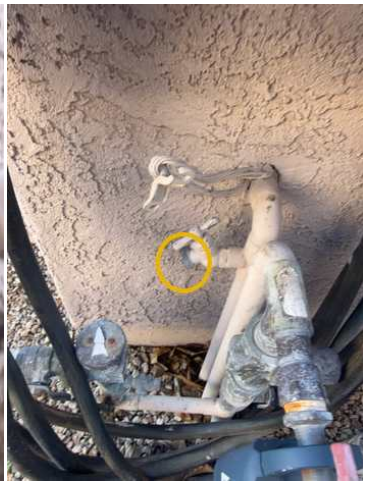
12.3.2 · Exterior Spigots

Spigot(s) - Upgrade to Anti-Siphon or Vacuum Breaker

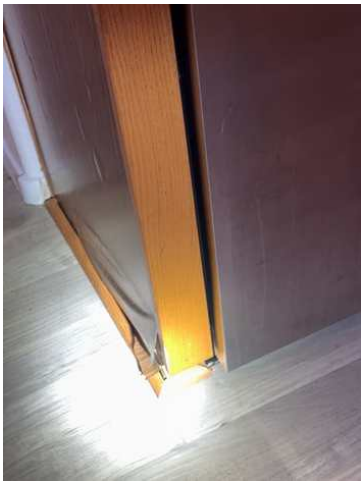
15.2.3 · Cabinetry, Countertops, & Associated Finishes

Cabinetry - Water Stains/Damage

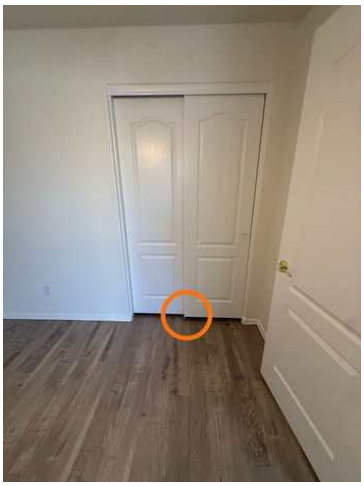
15.5.4 · Interior Doors

Sliding Door - Missing Guide Tracks

Observed that the sliding door lacks the required **door guides**, which are essential for smooth operation and proper alignment. This omission may affect door performance.

Recommend installing appropriate **door guides** to restore proper function.

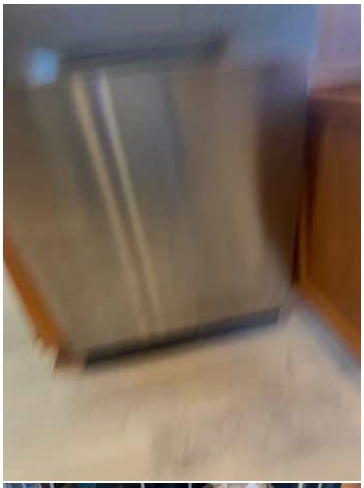
17.2.1 · Disposal

The food waste disposer was inspected by activating it at normal controls and ensuring the motor ran, while also looking for leaks from the unit, an exposed power cord, heavy rust, or other deficiencies. The unit is not tested to determine if it can effectively "grind" food waste. No reportable conditions were present at the time of inspection unless otherwise noted in this report.

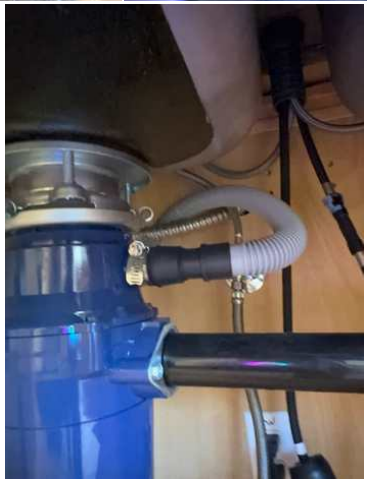
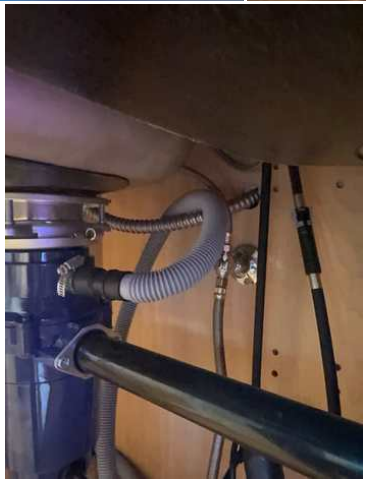
17.3.1 · Dishwasher

The dishwasher was operated by running a rinse cycle and was functional at the time of inspection. No leaks or water were present at the unit's base at the cycle's completion. The unit's efficiency of cleaning dishes is not tested. No deficiencies were observed with the unit unless otherwise noted in this report.

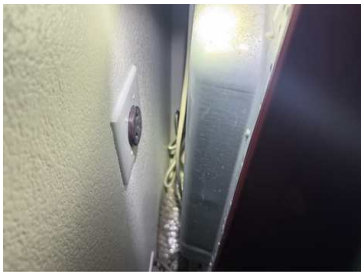
Washer was observed where visible. We recommend obtaining records from the homeowner for warranties and maintenance. We are not required to test non-permanent installed appliances per the BTR standards. Any pictures or comments made about the washing machine are as a part of courtesy only.

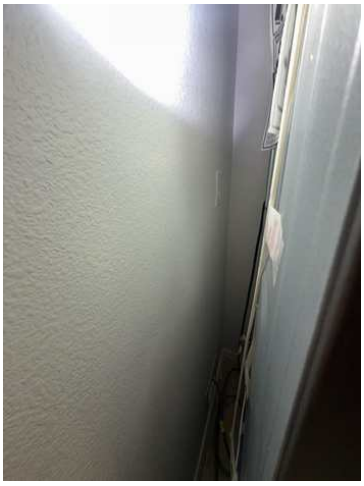
17.6.3 · Refrigerator/Freezer

Refrigerator - Unplugged, Operation Not Verified
